PESD, VOL. 12, no. 2, 2018

STUDIES AND RESEARCH ON NATURAL AND ANTHROPIC RISK THE MOLDOVA'S LOWER COURSE

Mihail Luca¹, Mihaela Avram², Alexandru-Lucian Luca³, Ștefania Chirica²

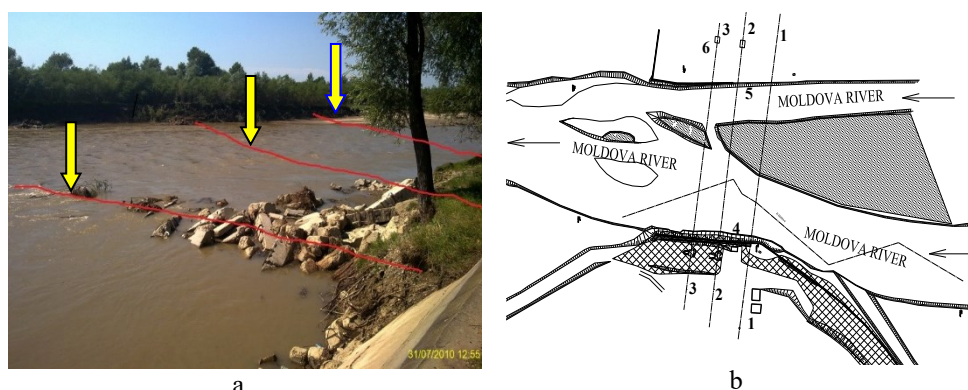
Fig. 2. Map of the undercrossing Moldova River in Soci zone: a – image of undercrossing adduction pipes; b – scheme of the protection works; 1, 2 and 3 – adduction pipes; 4 - protection works of the left bank; 5 – protection works of the right bank; 6 - inspection chambers.

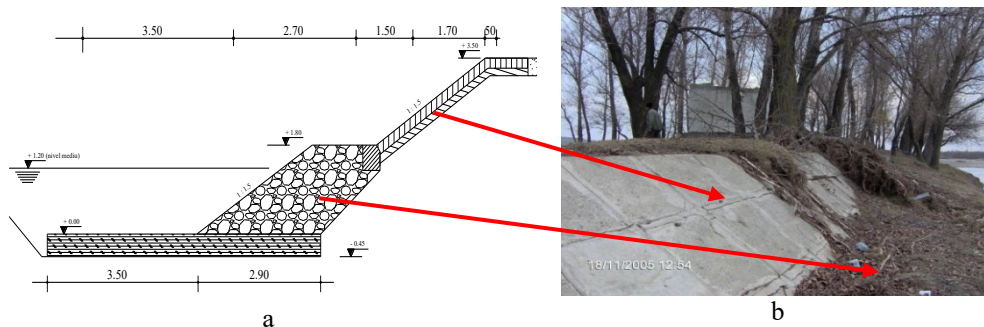
Research carried out between in the period 2004 - 2015 analyzed in detail the degraded phenomenon of shore defence works in the undercrossing area of the adduction pipes. The shore defence was carried out in 1971. It consists of two overlapping constructive structures (Figures 7.a, 7.b). The first structure is a massive stone 1.80 m high on a fascia mattress. The second structure consists of concrete slabs (50x50x10 cm) mounted on a ballast bed and supported on a simple concrete beam. The tile wall has a tilt slope of 1: 1.5 and is mounted at a height of 1.70 m (Figure 7.a). On-site research analyzed how the construction behaved over time at site factors.

During the first years of exploitation there was a clogging of the shores defence works. During the period 2005 - 2015 the hydrological and hydraulic regime was modified on the section with the undercrossing construction located on the Moldova River. Natural risk factors, corroborated with those of anthropogenic risk, have accelerated the degradation of shore defence works until their total destruction. The degradation of shore defence works was more intense on the left

Fig. 7. Images of the protection works on the Moldova River: a - execution detail; b - shore defence in 2005.

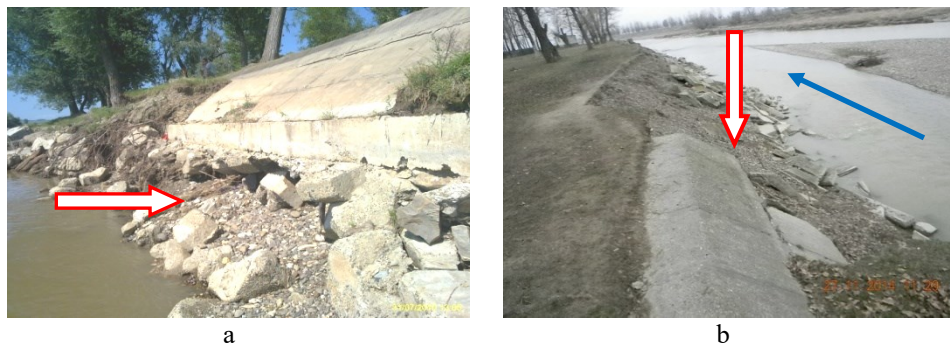
The degradation of shore defence works was carried out through the following destructive processes during the years 2005 - 2012. The degradation process included the steps: a - washing the alluvial offshore defence (Figure 9.b); b - removing the cement mortar from the joints and washing the ballast layer under the tiles; c - cracking and cracking of concrete slabs; d - the entrainment of the rock from the supporting mass and the collapse of the defence structure (Fig. 9.a); e - breaking of the support beam and the collapse of the concrete slabs; f - the entrainment of concrete pieces in the riverbed and the erosion of the bank (Fig. 9.b) (Luca M., 2012).

Fig. 9. Images of the protection works on the Moldova River: a - degraded left bank defence (2012); b - total left destroyed defence (year 2012) (Luca M., 2012).

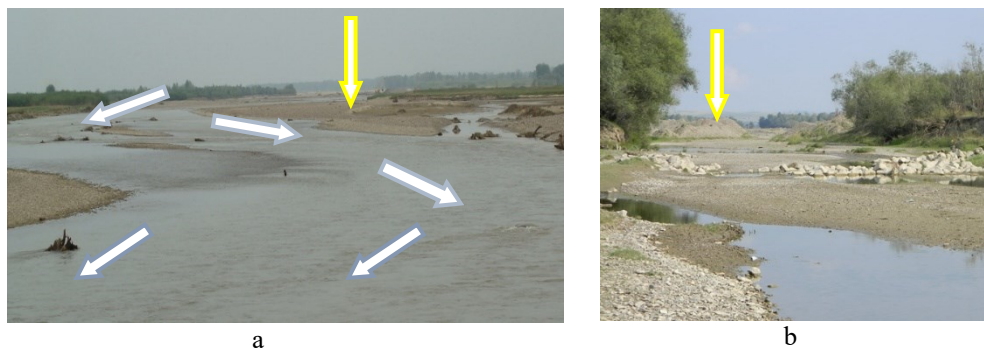
The accumulation of natural risk factors in the study area (floods, maximum flows, high frequency of peak flows, erosions, noncohesive rocks in the basin of the riverbed) with the anthropic ones (ballast exploitation, deforestation, absence of regulation and shore defence, the extension of the arable land) caused excessive degradation of the riverbed in the transverse and longitudinal plane (Fig. 11).

The excessive morphological modification of the riverbed caused the degradation of the stability and integrity of the adduction pipes Timisesti - Drinking for drinking water. Also, shore defence works and regularization works have been degraded differentially on both sides of the river. The shore defence on the right arm of the Moldova River was degraded by 90%, where the anthropic factor (ballast exploitation) occurred substantially.

Fig. 11. Anthropogenic risk factors (ballast exploitation) in the morphological modification of the river bed of Moldova: a - anthropic modification of the river flow paths; b - partial blocking of flow ballast deposits through the right arm of the river in the research area.
