## THE CLIMATE AND ITS IMPACTS ON EGYPTIAN CIVILIZED HERITAGE: EI-NADURA TEMPLE IN EL- KHARGA OASIS, WESTERN DESERT OF EGYPT AS A CASE STUDY

**Key words:** Roman monuments; El- Nadora Temple; Weathering forms; deterioration

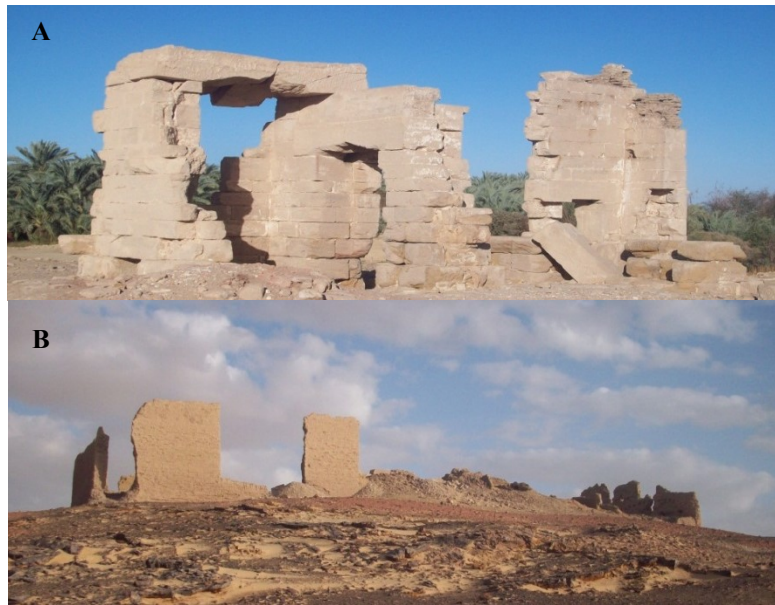
(Fig.2 A.B) Panoramic view of El-Nadora temple zone, (A) lower structure uninscribed and its dedication function are thus far unknown (B) The main temple surrounded by mud-brick walls

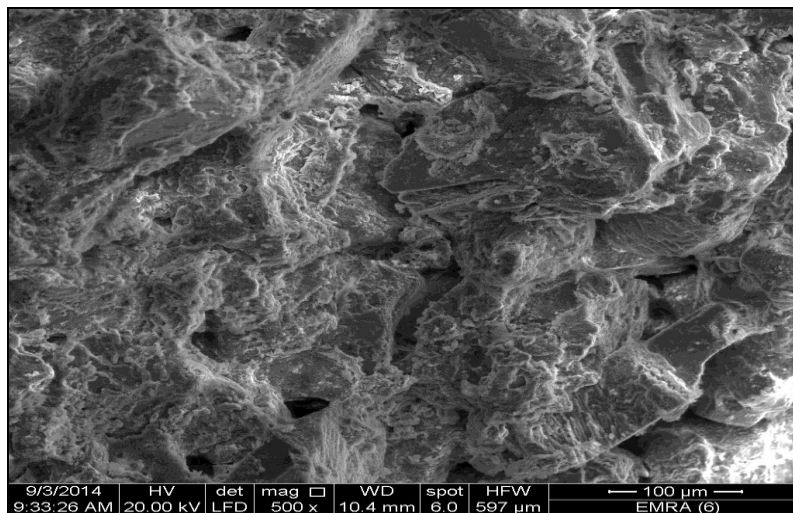
below the dew point. High temperatures during the days draw the moisture out of pores towards the surface. This water evaporates, with resulting crystallization producing forces adequate to weaken or even disrupt the stone (Fig.3).

(Fig.3) Scanning electron micrograph of deteriorated stones of El-Nadoura Temple showing Crystallization occurs initially in the small and large pores

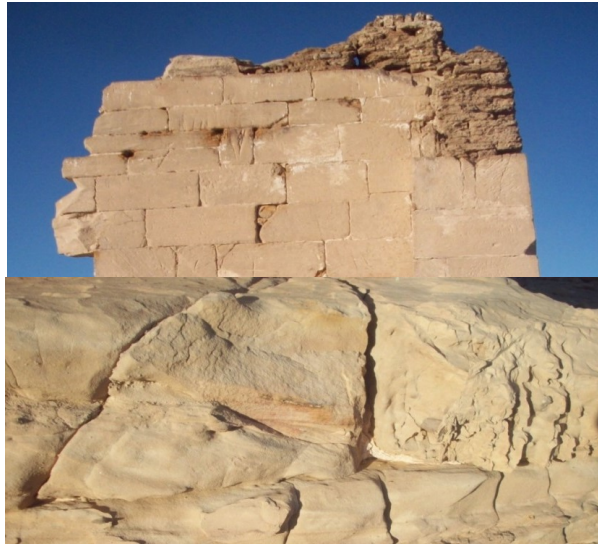
Cracks are more effective features of weathering resulting either from the effect of mechanical stress due to crystal growth or biological growth (El-Gohary, 2010). Several longitudinal single cracks are observed on the vertical wall of El-Nadoura Temple, cracks are typically several millimeters in width and centimeter in length, due to arid climate and wide range of temperatures with very hot days and very cold nights (Fig.4 A.B).

Fig. 4. A, B. Longitudinal single cracks on the wall of El-Nadira Temple, millimeters in width and centimeter in length, due to arid climate and wide range of temperatures.

The thermal expansions do not occur only because of hot weather at afternoon but also freezing process as a result of decreasing of temperature at night, the frozen dew fall in cracks presents a cotter effect, enlarges the cracks and causes to have broken pieces of stones (Abd El-Aziz, 2012). But thermal expansion can also occur in larger zones of the rock itself. The rock surface is more affected by insolation than the deeper part of the rock. Thus, thermal expansion depends on the orientation of exposure of a rock wall (south, west, north, and east) (Fig.5). When this event takes place for several times, the broken upper layers of stones will be observed. Freezing-thawing process has a significant effect on deterioration of stones used at the regions facing with daily and seasonal temperature changes (Yaldiz, 2010).

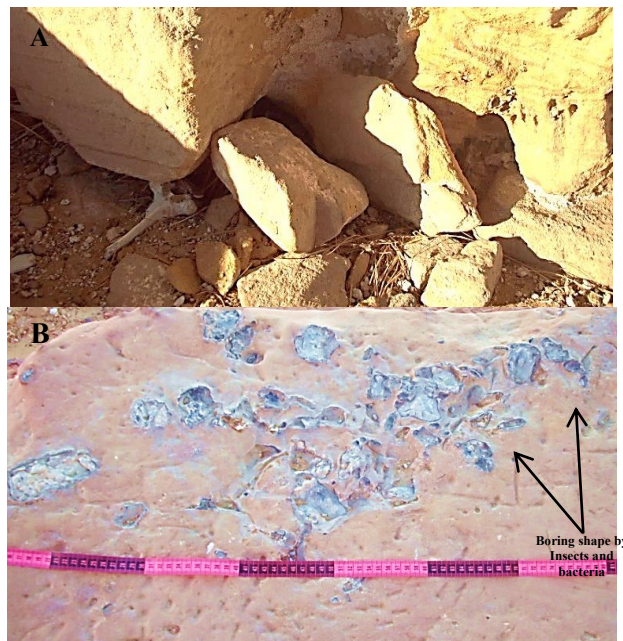
Fig. 6. A. B Biological deterioration at El-Nadora Temple showing boring shape by animals in (A), boring shape by insects, bacteria and fungi effect in (B)

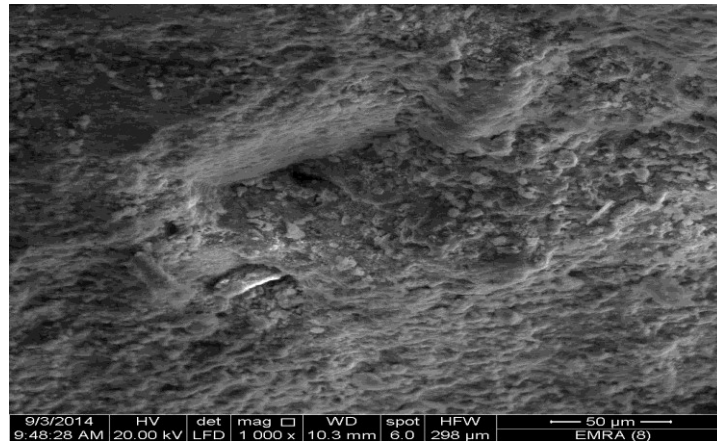
According to (El-Gohary, 2010), exfoliation is a type of physical weathering in which the outer layer of a rock surface peel off in flakes and shells. It is caused by the rapid expansion and contraction of the rock surface when subjected to extreme change of temperature. Exfoliation occurs particularly in hot dry climates as a result of thermal expansion, so it can be observed this type of weathering in El-Nadora Temple (Fig.8).

Fig. 8. Scanning electron micrograph of deteriorated stones of El-Nadora Temple Showing micro-exfoliation grains

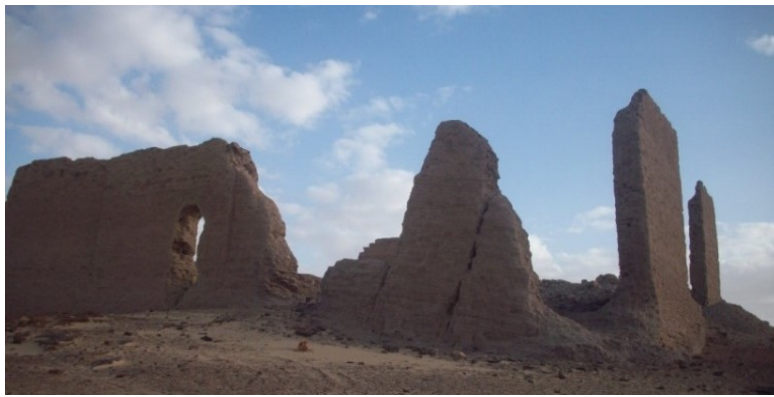
A complex combination of mechanical, chemical and biological factors played an important role in the deterioration of building stones of El-Nadora temple walls, such as unstable walls (Fig.9). The processes of mechanical deterioration affecting the calcarenit and the aeolianite building stones are boring, abrasion, polishing, scouring, scratching, splitting, fragmentation and rock fall (Fig.10). These processes are reflected by striations, polished surfaces, undulating surface, cracks, fissures and joints and finally rock fall (Mahmoud, 1995).

Fig. 9. The presence of structurally unstable walls at El-Nadora Temple as a result of physical weathering (natural causes), or constructional causes

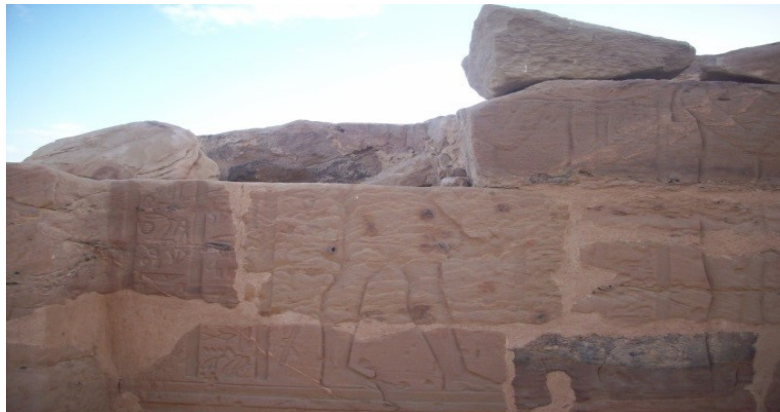
Fig.10. Original Text stone insets that have been lost leading to cavities, with the original stone still in the vicinity

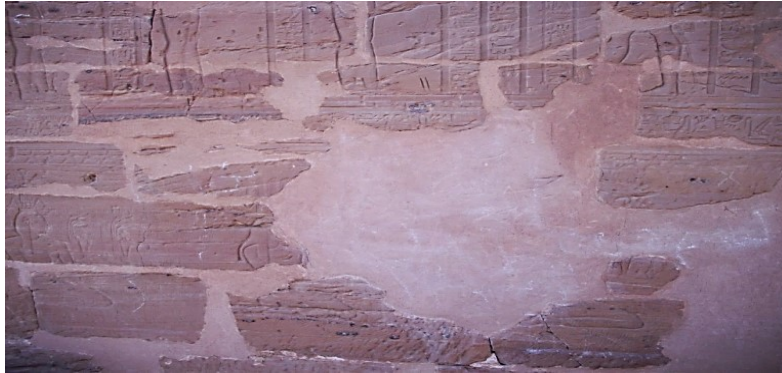
Fig. 11. The disappearance of the texts, symbols, inscriptions as a result of the deterioration caused by physical and chemical weathering

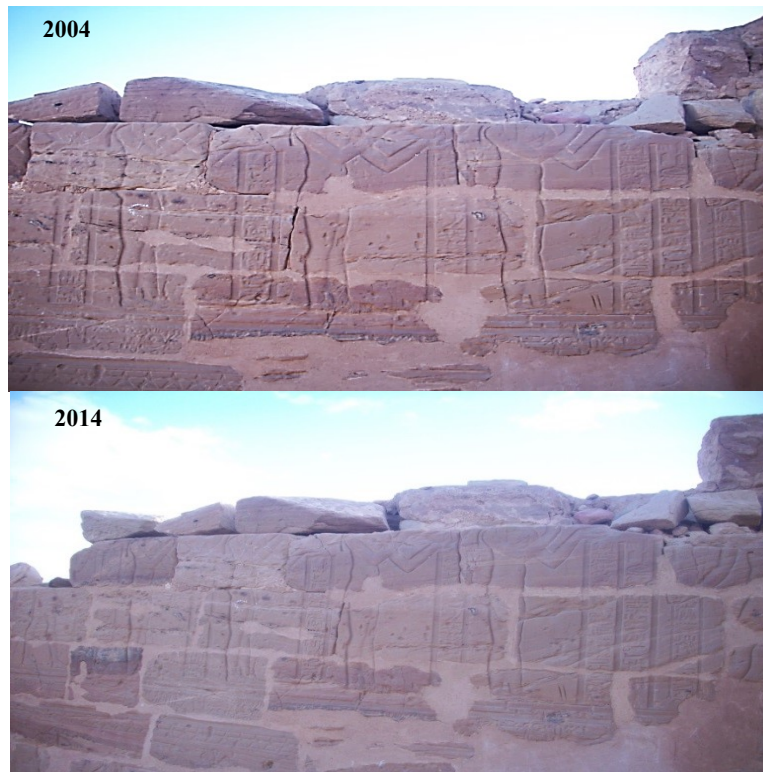
Fig. 12. Progress of clarity of archaeological inscriptions and texts as a result of the deterioration caused by the wind carrying sand between the years 2004-2014

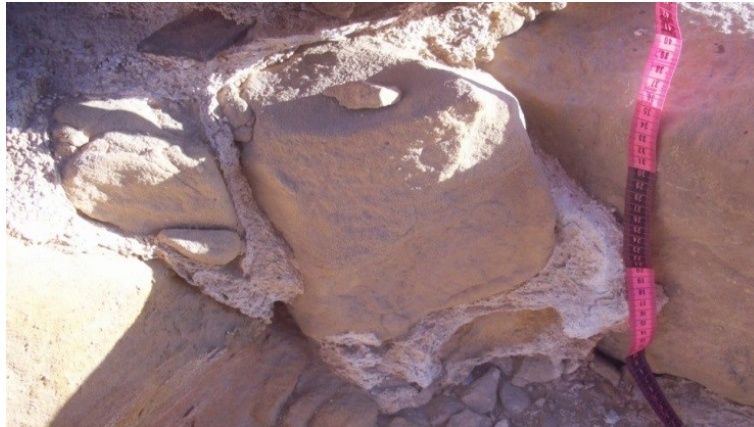
Fig. 13. Disintegration of the mortar used in jointing the stones wall at El-Nadora Temple as result of climate conditions

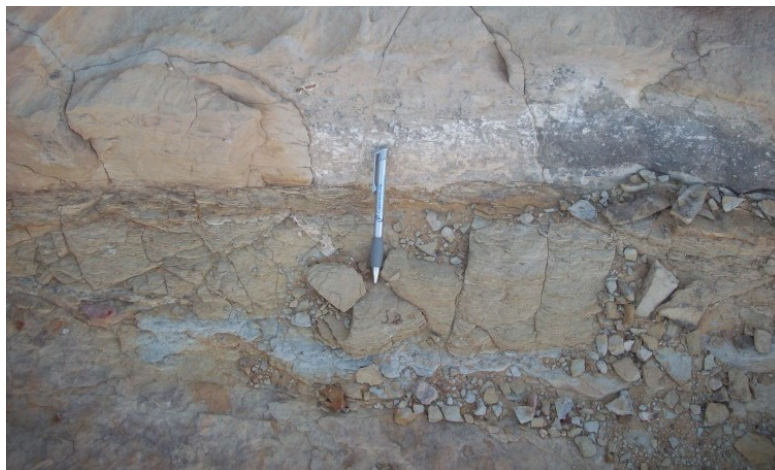
Fig. 14. Detachment of small, flat, thin pieces of the outer layers (Flaking) of El-Nadora Temple stones

Chemical weathering erodes the stones changing their compositions by chemical reaction. Chemical weathering of the stone takes place through dissolution, hydrolysis and oxidation processes of the stone minerals. Chemical weathering is mostly due to the effects of climate conditions, and caused a lot of deterioration features, such as disappearance of the texts, symbols, inscriptions (Fig.11) and (Fig.12). Disintegration of the mortar used in jointing the stones wall (Fig.13), or flaking the stone (Fig.14). Biological weathering can be described as a

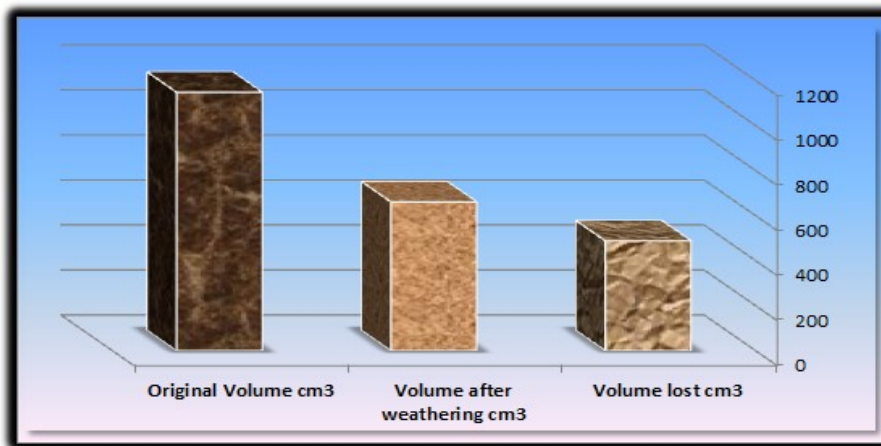
weathering and other blocks which highly weathered, then measured the length, width and depth in each block to determine the volume. Therefore, the rate of weathering was measured for six building stone blocks at El-Nadoura Temple which have an age of 2152 Year in 2014. The total weathering rate according to the age of El-Nadoura temple is  $518 \text{ mm}^3$  per year from 138 BC to 2014, and this means that the temple faces a real risk of the elements of the climate (Table.2), (Fig. 15).

Fig. 15. Average volume of weathering related to total average volume of rock at El-Nadoura temple.

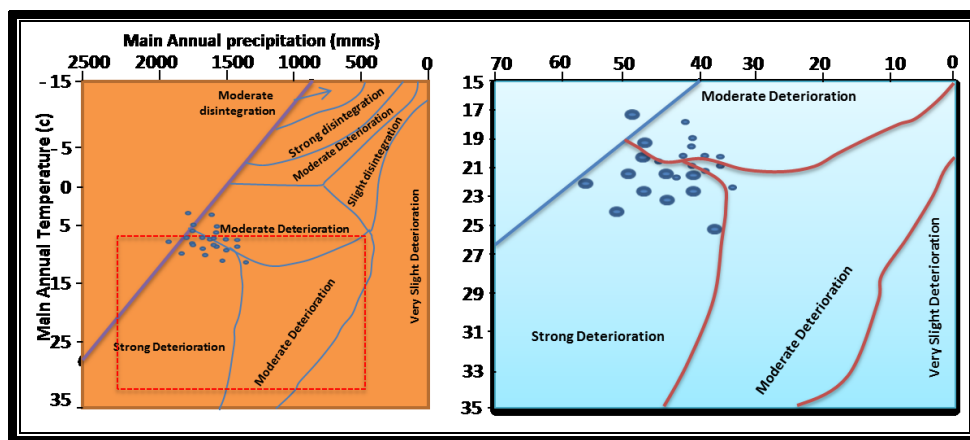
In order to examine the influence of climate conditions on cultural heritages, this study applied the correlation diagram of climate conditions and weathering designed by Fookes et al. (1971). Using the data collected for the last 60 years on mean temperatures and precipitations. As a result, the regions influenced by El-Kharga climate conditions are classified into three groups: strong deterioration, moderate deterioration and very slightly deterioration (Fig.16).

Fig.16. Correlation diagram between climate and Deterioration affecting El-Nadira Temple Modified after Fookes et al., 1971
