## ANALYSIS OF PHENOMENONS WITH HYDROLOGIC LARGE RISK IN THE HYDROGRAPHIC BASIN OF THE TROTUȘ RIVER

**Abstract:** The paper presents an analysis of the high hydrological risk phenomena formed in the hydrographic basin of the Trotuș River in the last period of time. The Trotuș River and the tributaries are monitored by 21 hydrometric stations. Precipitation volume processing indicated a number of risk factors that have prevailed over the last 20 years. The hydrological data processing revealed the presence of several flood flows in the same year. The effects of the floods have materialized through the excessive degradation of river bedside regulation and shore defence works. The floods of the past 25 years have resulted in the destruction of a large number of economic and social objectives in the Trotuș River area, as well as human losses. Parameters of hydroclimatic risk highlighted by research are represented by torrential precipitations, floods with high probability, high frequency of high-flow flows, formation of high erosion velocities of the bed, etc. Parameters of hydroclimatic risk impose special conditions for the design of river regularization and shore defence.

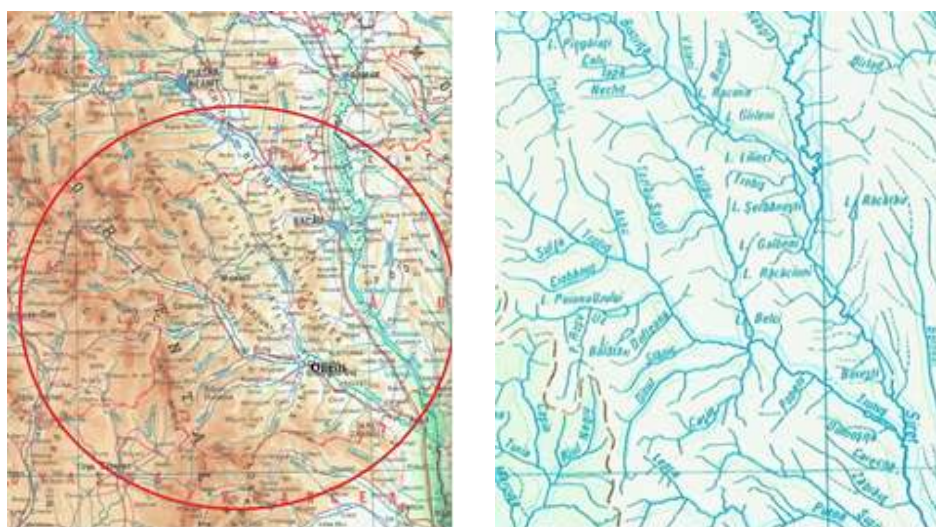
Fig. 1. Location of the study area in the Siret catchments area: a - details of the relief areas in the Eastern Carpathians; b - the hydrographic network characteristic in the study area

The tributaries on the right are more numerous and have larger hydrographic areas (Uz - 469 km<sup>2</sup>, Oituz - 337 km<sup>2</sup> and Cașin - 308 km<sup>2</sup>). They drain higher mountain areas and have a richer leak. The most important tributaries on the left are Asaul - 208 km<sup>2</sup> and Tazlăul - 1104 km<sup>2</sup> (Fig.1).

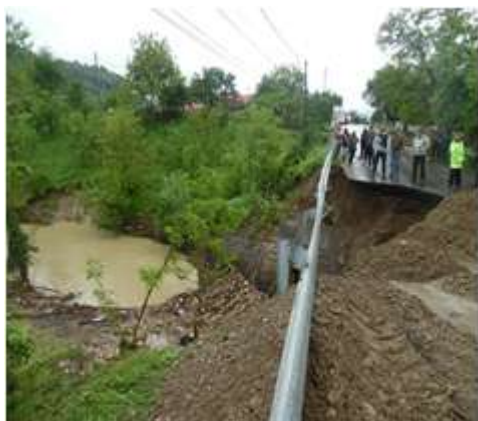
Fig. 6. General view of a landslide, the Cașin River, with the degradation of the road (Avram M., 2016)

Hydrotechnical works were strongly affected by the 2016 floods in the Trotuș catchment area, where approximately 35.46 km of partially and totally degraded works were centralized (ABA Siret, 2016).

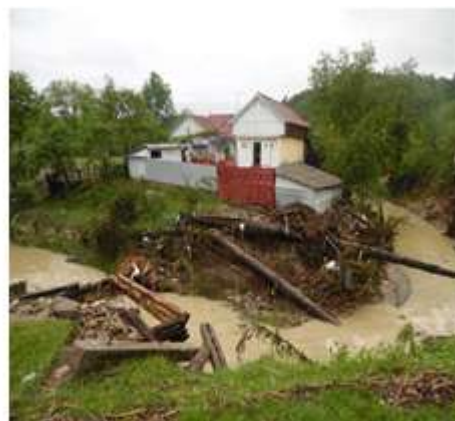
Fig. 7. The degradation of the riparian area on the Flooding Cașin River in June 2016 (Avram M., 2016)

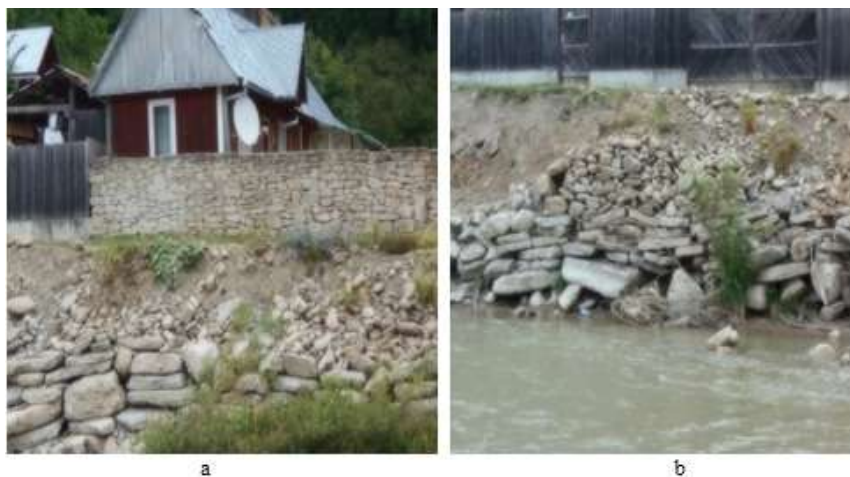
Fig. 8. Erosion of the Trotuș River in June 2016: a - erosion in the area of dwellings; b - the erosion of the county road (Avram M., 2016)

- the current riverbed (minor and major) has a low transport capacity for floods with high flows;
- the current riverbed is morphologically modified, with the formation of sedimentation and erosion zones, influencing the flood transit capacity;
- increasing transport of biological material in the bed (branches, wood waste, trees, etc.), which causes the blocking of the river bed section in the bridges area;
- uncontrolled deforestation that has intensified rainfall-drainage and water-streaming in rivers;
- the continuous degradation of the flow regulating works on the non-permanent (torrential) alluvial basins in the hydrographic basin, which causes the tributary flow to be increased in the main bed;
- modification of drainage coefficients in the river basin due to anthropogenic intervention.
