THE ANALYSIS OF THE FLASH FLOOD PRODUCED DURING 02-04.06.2016 IN THE TROTUȘ RIVER BASIN (ROMANIA)

Abstract: This paper concentrates information on the flash flood produced during 02-04.06.2016 in the Trotuș River basin. Maximum flows have been analyzed by reference to the thresholds corresponding to the Defense Levels. In order to show in a suggestive way the amplitude of the event, the characteristics of the flood were highlighted as well as a series of morphometric and hydrological data on the maximum flow of the Trotuș River. The hydrometric stations in the basin area, to which reference was made, were: Lunca de Sus, Goioasa, Tg. Ocna, Onești and Vrânceni. The flow series were represented graphically to be able to easily observe the evolution of the flood over time. The analysis showed that the flood produced on the Trotuș River had a great magnitude causing significant damages.

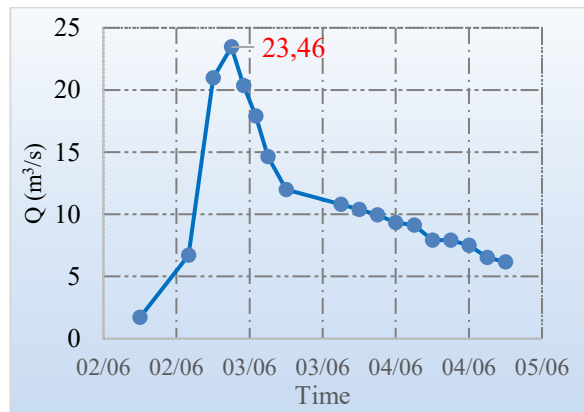
Fig.3 - Flood hydrographer, Trotuș River, Lunca de Sus hydrometric station, 02-04.06.2016

As a result of the significant rainfall that occurred in short intervals and due to the significant water flow from the slopes, during the analyzed period there were important increases in flow rates on the watercourses in the upper and middle basin of the Trotuș River (Fig. 3,4,5,6 and 7). The following precipitations were recorded at the analyzed hydrometric stations: 38,2 l/sqm Lunca de Sus; 93,5 l/sqm Goioasa; 59,6 l/sqm Tg. Ocna; 78,2 l/sqm Onești and 42,2 l/sqm Vrânceni, and the average precipitation in the entire Siret basin in the Bacău County area was 60l/sqm. The highest recorded flow (2524 sqm/s) was the one from Vrânceni downstream station (03.06.2016, 02:00), with a level of 525 cm, thus exceeding by 25 cm the Danger Level. At Lunca de Sus, Tg. Ocna and Onești hydrometrical station, the levels exceeded the specific Flood Levels by more than 20 cm. The characteristic

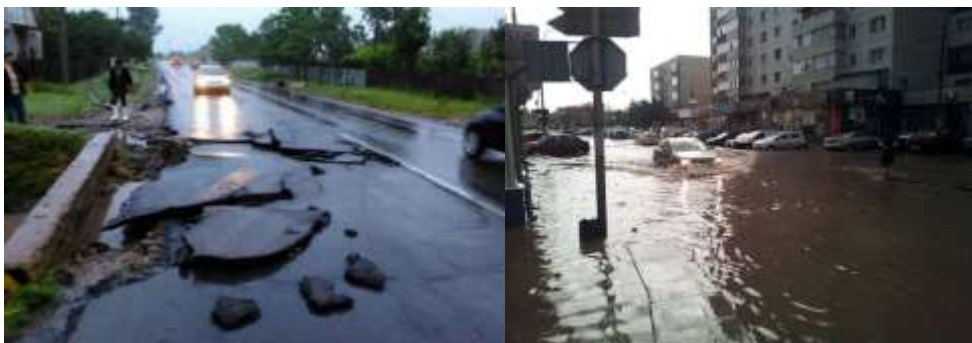
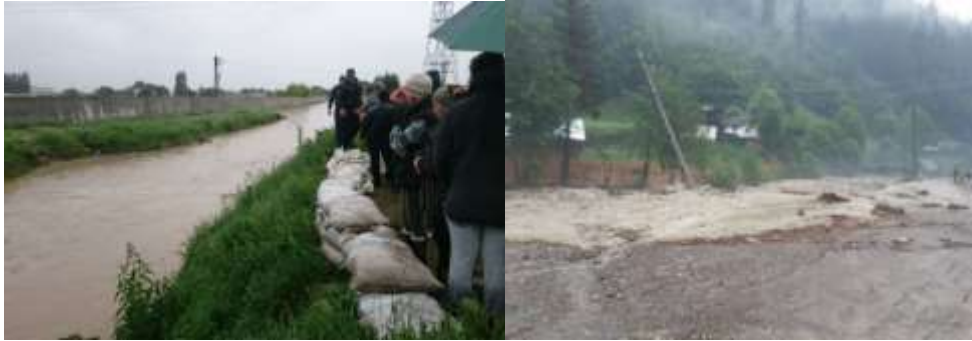
Fig.9 – Damage caused by the flash flood, Trotuș River, June 2016. Source: www.bacău.net

Also in the paper the situation of damages produced, the objectives affected (Fig. 9) and the causes of these phenomena will be presented. The following software packages were used for data processing: EXCEL, CAVIS and GIS.

On the basis of the operational report on the effects of the dangerous hydrometeorological phenomena produced during the analyzed period, a total of 23 UAT's with 61 affected villages resulted in 32 flooded houses, 442 flooded house holds, 16 isolated households, over 100 km of affected roads, 4 km of sewerage network, 26 bridges, 87 culverts, 9 decks, 1060 ha of agricultural land, 200 ha of pasture land, 0.69 km of shoreline, 3 socio-economic objectives, 0.3 km CF, a damaged gas pipe, 3 damaged salt water pipelines, one car and a deceased person. The flood affected also the hydrotechnical constructions, namely: 1 concrete pile and destroyed gabions.

Among the causes that have led to these phenomena are mainly included torrential rainfall (90 l / mp in 30 min), flow increases, leakage on the slopes, overflowing of tributaries and significant accumulations of water with sediments. During this interval, 4 orange and red code warnings were issued, of which 2 for immediate phenomena (Fig.8). Regarding the actions and interventions for diminishing the effects of the dangerous hydrometeorological phenomena

undertaken by SGA Bacau during 3.06.2016 we mention: removing obstacles by workers and unlocking of the clogged river bed, to ensure the drainage section, as well as the evacuation of the water from the flooded area.
