EVALUATION OF DAMAGES CAUSED BY FLOODS, BASED ON SATELLITE IMAGES. CASE STUDY: JIJIA RIVER, SLOBOZIA-DÂNGENI SECTOR, JULY 2010

Elena Hutanu¹, Andrei Urzica², Andrei Enea^{3,4}

Key words: flood, GIS, Jijia river, Remote sensing, damage assessment

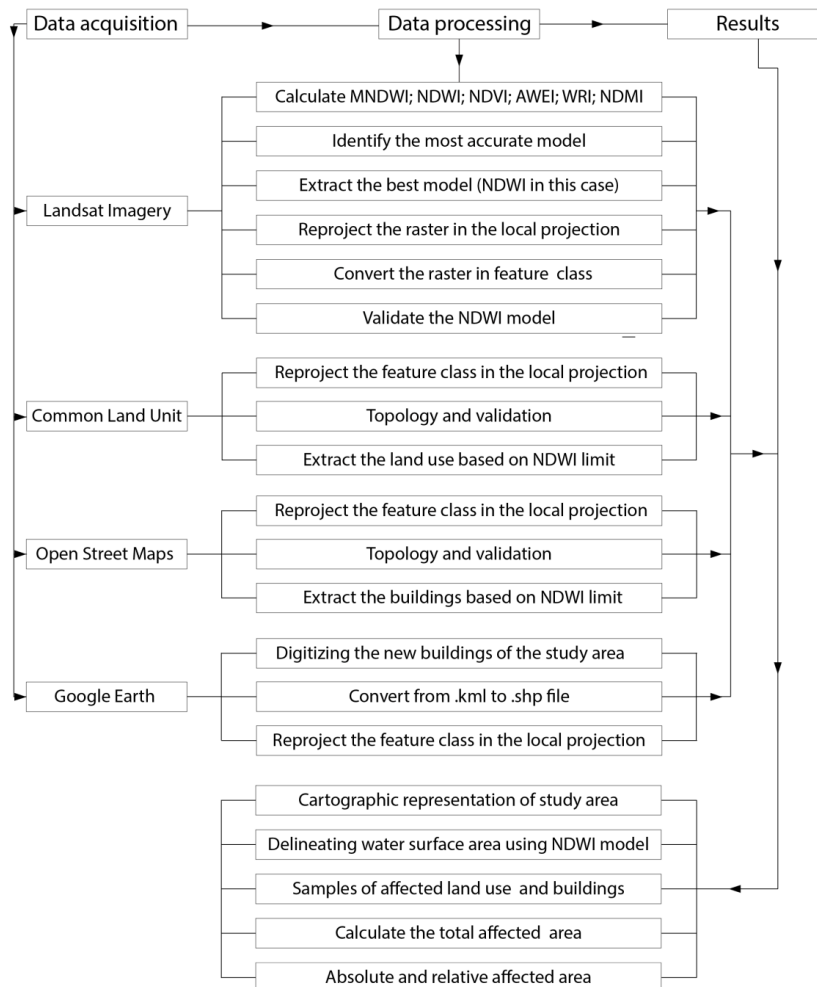
Figure 2: Landsat 7-ETM + image processing scheme for flooded surfaces

For this study, two important steps were taken: the data acquisition and processing stage (Fig. 2). Thus, in the first stage, a set of data was gathered, both in raster format (satellite images) and in vector format (land use and buildings).

The data processing step involved a series of operations that included raster and vector files. Six indices for water body identification (MNDWI, NDWI, NDVI, AWI, WRI and NDMI) were calculated in the first phase. This operation was necessary to get the model with the highest accuracy. Of the six calculated indices, the NDWI index was chosen. The next step was to extract the flood limit of the indices, that was also used for future processes. The limit obtained was validated and brought to the local projection system.

Regarding the vector layer, they were also brought to the local projection system, followed by the validation of each layer using appropriate methodology. A last step was to extract the land use, based on the flood limit of the chosen indices, calculate the flooded areas, generate descriptive statistics on the comparisons between the categories of land use flooded, but also to create representative cartographic material (Romanescu et al., 2017b; Romanescu, 2018).

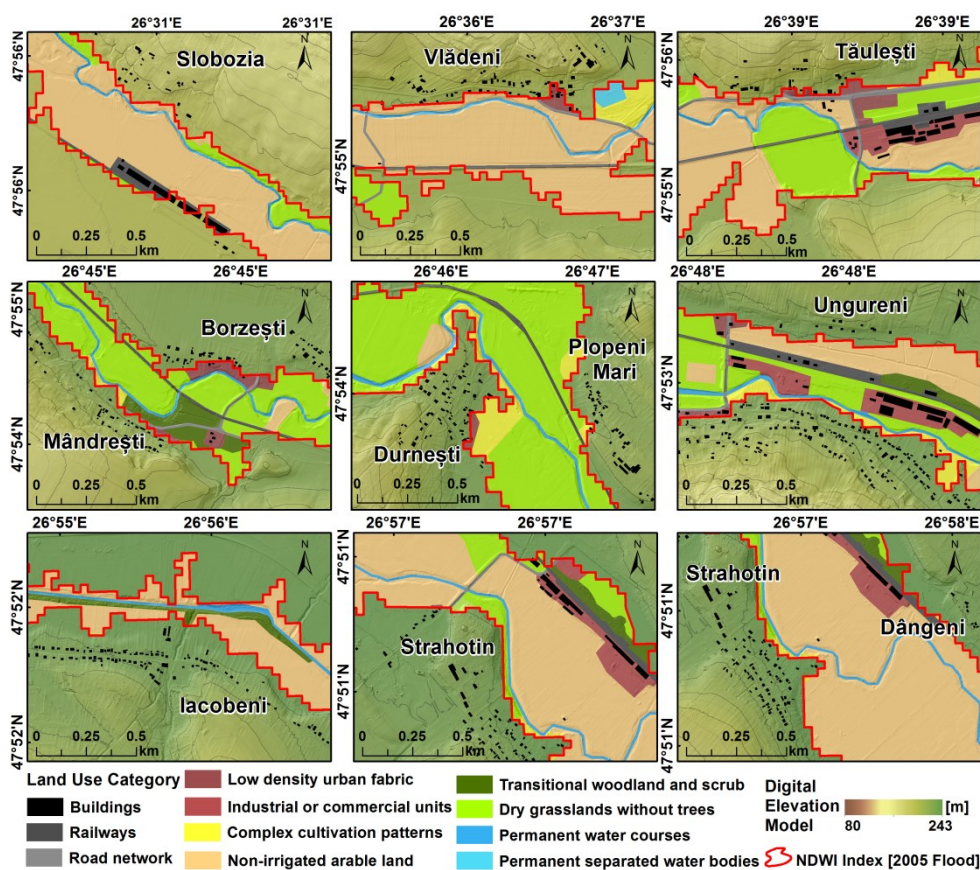
Figure 3: Areas affected by the floods in July 2010 obtained using the NDWI index

2010, the flood was still widening. At Dimăncieni, the Jijia River flows along the left bank of the minor bed with 632 m, flooding households and farmland. In the locality of Corlățeni, the flood extended into the floodplain, passing by the left bank of the river bed, by 580 m and to the right, by 610 m. In the locality Mateeni locality, Jijia extends into the floodplain, reaching a width of about 500 m, the same situation being present in the localities of Vlădeni and Tăulești. In Călugăreni, the width of Jijia River narrows, reaching a value of approx. 320 m, but at Mândrești and Borzești returns to the same average of 500 m wide. Between the Plopenii Mici and Durmești, on the right side of the river, the flood extends approx.

1 km (950 m), after which the flood extension decreases in the localities of Durnești, Plopenii Mari and Ungureni, the extension of the flood reaching a width of approx. 400 m at Sapoveni the flood extends to the left of the minor bed by about 1 km, and it will decrease in the districts of Epureni and Vicoleni to 200 m. In Strahotin and Dângeni the flood extends over a width of about 700 m (Fig. 3).
