Annals of Warsaw University of Life Sciences – SGGW
 Land Reclamation No 47 (4), 2015: 333–342
 (Ann. Warsaw Univ. of Life Sci. – SGGW, Land Reclam. 47 (4), 2015)

Hydromorphological and landscape valorization of the Poprad river valley

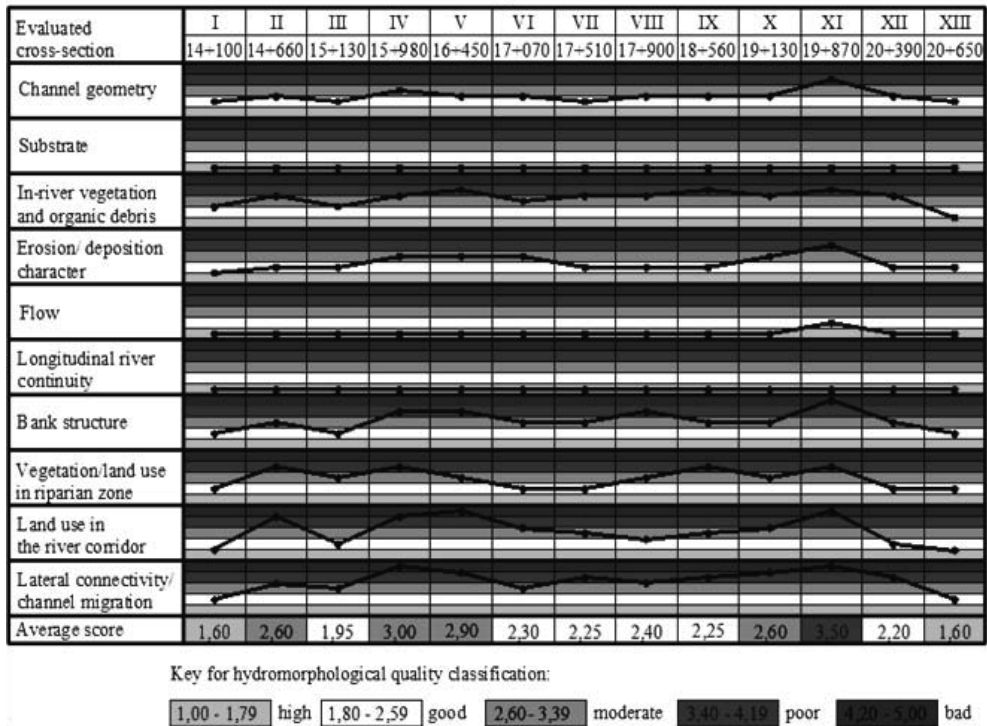
FIGURE 2. Evaluation of each hydromorphological features for I to XIII evaluated cross-section on the Poprad river with the average assessment made against the background of the classes of the hydromorphological quality

The results of each category of features and hydromorphological quality class for the Poprad river were presented in Figure 2. The hydromorphological assessment shown considerable variability, mainly in features which describe banks, riparian zone and floodplain area.

Cross-section I (km 14+100) and cross-section XIII (km 20+650) were classified as the first class of hydromorphological quality on the river (high). It was considered that these cross-sections are slightly transformed by human (cross-section I is in Fig. 3). Cross-section III (km 15+130), from cross-sections VI to IX (from km 17+070 to 18+560) and cross-section XII (km 20+390) belong to the second class of hydromorphological quality of the river (good). The third class of hydromorphological quality of the river (moderate) has been assigned to cross-sections II, IV, V and X (sequentially km 14+660, 15+980, 16+450 and 19+130). Cross-section XI (km 19+870) was classified to the fourth class of hydromorphological quality of the river

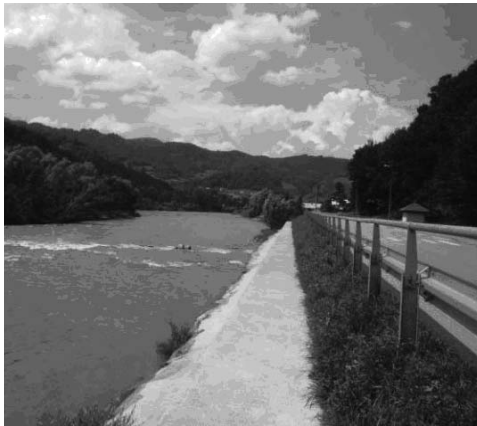
FIGURE 3. Concrete embankment as a strengthening of the right bank of the river – cross-section XI (km 19+870), (photo by M. Nawieśniak)

(poor). This assessment is mainly due to strengthening of the right bank by a concrete embankment to approximately 3 m (Fig. 4). This strengthening was made to secure the road which is located in the immediate vicinity of the river channel. That entirely changed the character of the river bank, and interrupted the connection between the river and the floodplain area.

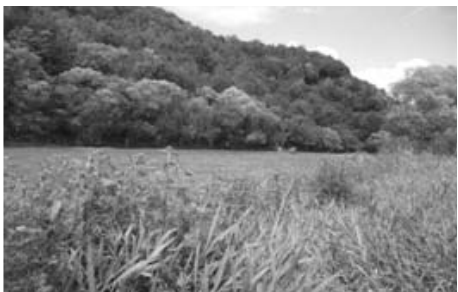
FIGURE 8. Cross-section VIII (km 17+900), (photo by M. Nawieśniak)

<p>Another cross-section was classified to second class of hydromorphological quality. The landscape value very similar to that in III and VII cross-section. Land cover: the right bank of the river – trees, and the left bank – meadows</p>

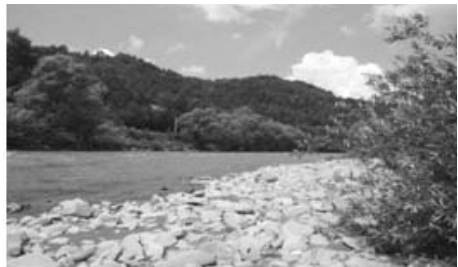
FIGURE 9. Cross-section IX (km 18+560), (photo by M. Nawieśniak)

<p>This cross-section was classified to second class of hydromorphological quality. The left bank of the river has been strengthened, but in a way that does not affect the overall value of the landscape</p>

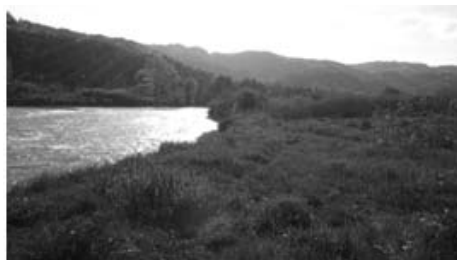
FIGURE 10. Cross-section XII (km 20+390), (photo by M. Nawieśniak)

<p>From the point of view of hydromorphological assessment this cross-section was classified to second class of hydromorphological quality. Also, this cross-section has landscape values that provide high-value landscape of this area</p>

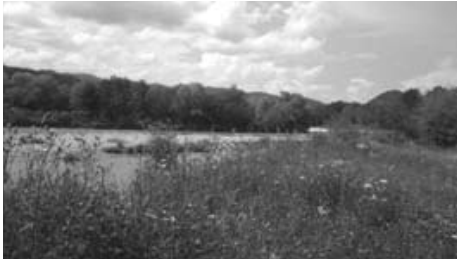
FIGURE 11. Cross-section XIII (km 20+650), photo by M. Nawieśniak)

<p>The last cross-section and it was classified to first class of hydromorphological quality. In addition to high hydromorphological assessment of this area it is also characterized by high landscape value</p>
