## Analysis of technical feasibility of status improvement the river and valley environment on the example of selected objects

ZBIGNIEW POPEK, MICHAŁ WASILEWICZ

Faculty of Civil and Environmental Engineering, Warsaw University of Life Sciences – SGGW

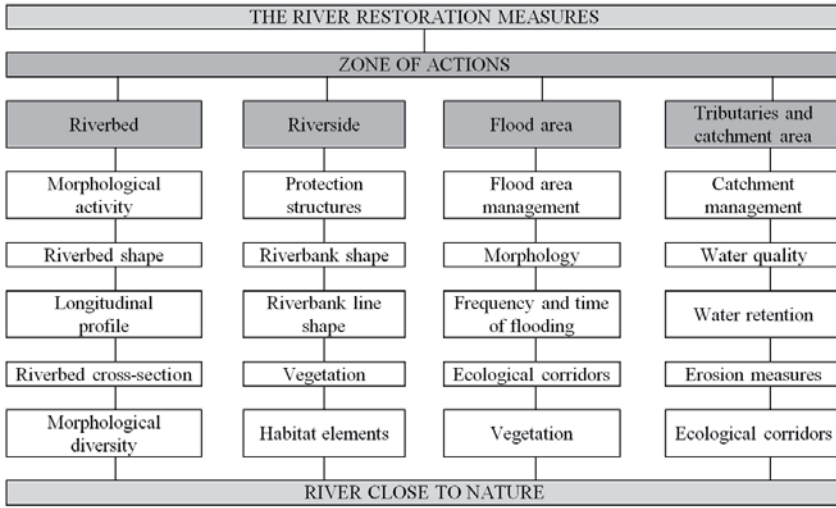
FIGURE 1. The river restoration measures (Kern 1992 – scheme partly modified)

River restoration objectives are achieved through appropriate actions that can be carried out in four areas (Fig. 1): riverbed, river bank zone, valley floodplain, tributary and catchment area. Typically, river restoration does not cover all of the mentioned areas and is limited to the selected one or two zones and a few specific actions.

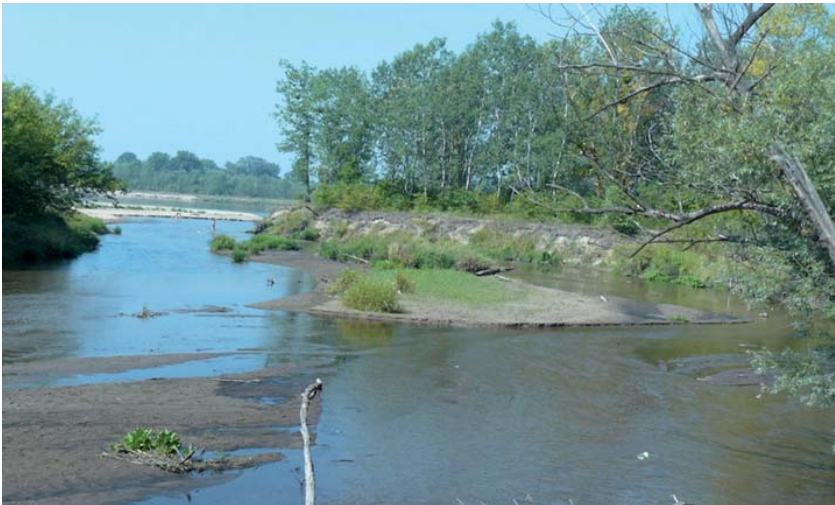
FIGURE 3. The view of the Świder river mouth into the Vistula river (Moruś 2015)

The Świder river is the right-bank tributary of the Vistula river, whose estuary is located at km 491 of the waterway (Fig. 3), i.e. about 10 km above the southern border of Warsaw City. The length of the Świder river is 94.5 km and the catchment area is 1,149.3 km<sup>2</sup> (Czarnecka 2005). The mouth of the Świder river is located partly in the Natura 2000 area of the Vistula River Central Valley and near the Vistula nature reserve: Świdorskie Islands and Zawadowskie Islands (Fig. 4).

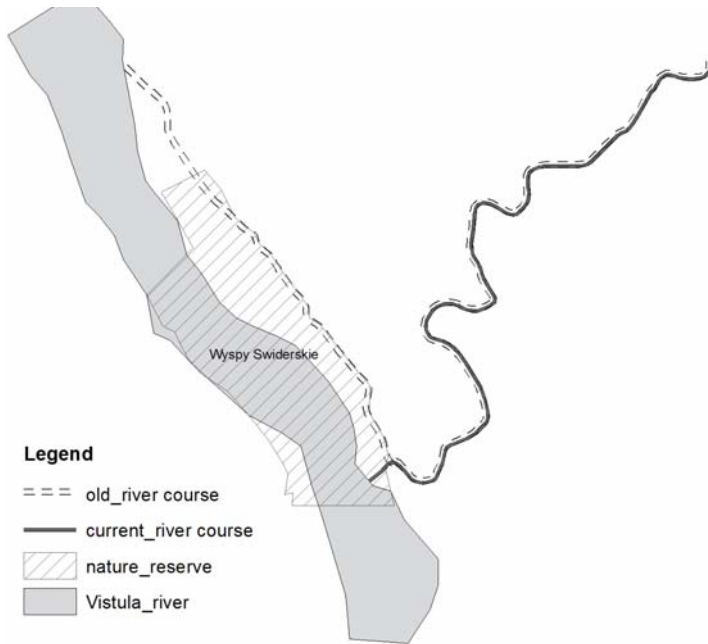
FIGURE 4. The aerial view of the current estuary of the Świder river with visible sediment deposits in the Vistula riverbed ([www.geoportal.gov.pl](http://www.geoportal.gov.pl))

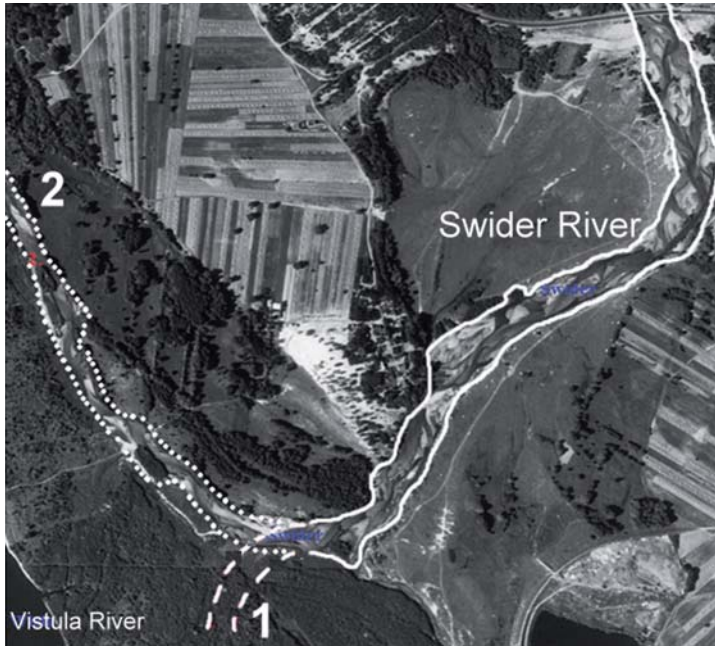
FIGURE 5. The aerial view of old estuary (2) of the Świder river with visible multi-thread braided channel and location of present estuary (1)

the Vistula river (Fig. 5). As a result of river regulation, the length of the river was reduced by approximately 5.5 km, which resulted in a gradual increase of the longitudinal riverbed slope from the initial value of 0.55‰ in 1966 to 1.05‰ in 2013 (Fig. 6). The increase of the water surface level's slope nearly twice as more as it was in past resulted in increasing of the water flow velocity, which in turn caused riverbed deep erosion – the bottom elevations in the thalweg fell by 2–2.5 m. There were also morphological changes of the river type – the Świder riverbed from the relatively shallow and wide transformed into a single channel river, with a deeply cut and narrow cross-section. Lowering the bottom also caused adverse negative changes in the river valley – decreased the frequency of flood flows and the

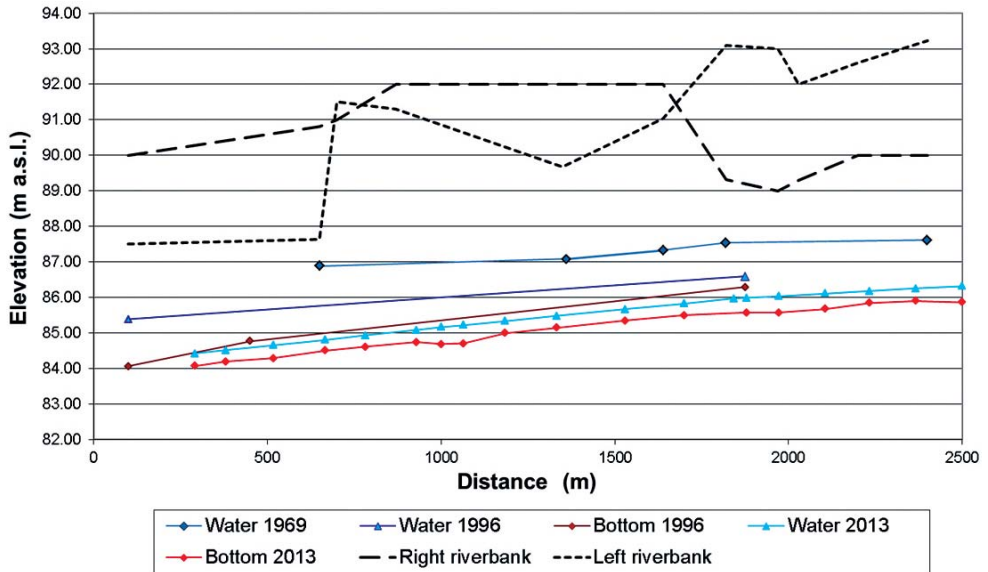
FIGURE 6. The longitudinal profile changes on of the Świder river estuary section (Moruś 2015)

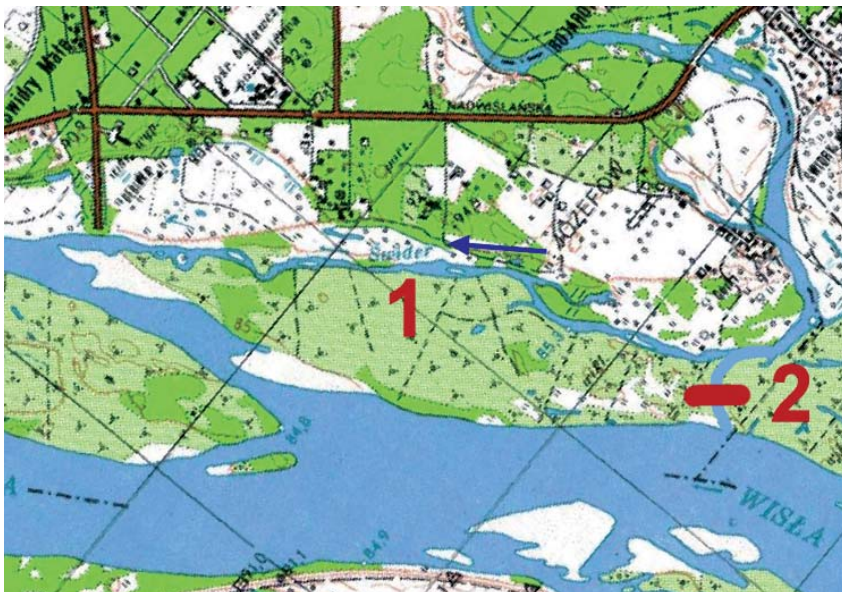
FIGURE 7. The Świder river project – proposed technical solution marked as follow: 1 – restoration of the old riverbed, 2 – gabion weir for closing current river mouth (Moruś 2015)

The proposed technical solutions include (Fig. 7):

- reconstructing the former riverbed location (which partly preserved in the form of oxbows) and the mouth of the Świder river to the Vistula river;
- closing of the present mouth of the Świder river to the Vistula river with a fixed gabion weir, which should be maintain the flow distribution so as to keep the minimum discharges in both branches – old and new one of the Świder river.

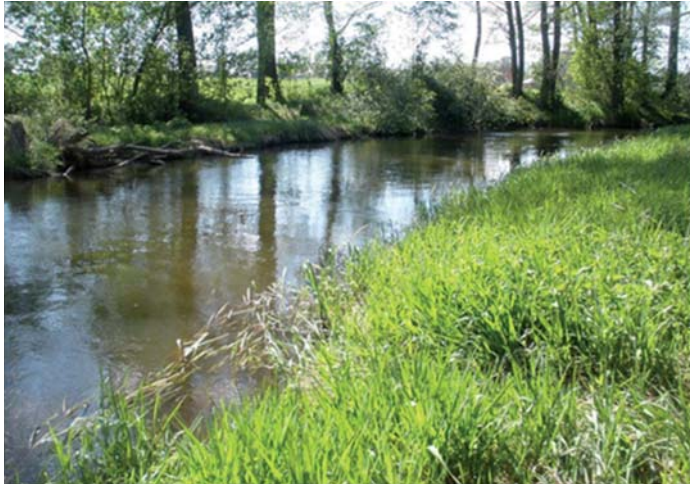
FIGURE 8. The view of the Rawka riverbed (photo Anna Opalińska)

The Rawka river is located in the Vistula river basin, is the right tributary of the Bzura river in km 43. The total area of the Rawka river catchment is 1,191.7 km<sup>2</sup>, while the river length is 105.1 km (Czarnecka 2005). The analyzed middle section of the river has the character of a natural, mostly single channel meandering lowland river (Fig. 8). In the past, there were many mills weirs built along the Rawka river. Between years 1800 and 1880 there were 18 weirs in the 38.5 km long section of the river, of which 9 have been preserved up till now (Fig. 9).

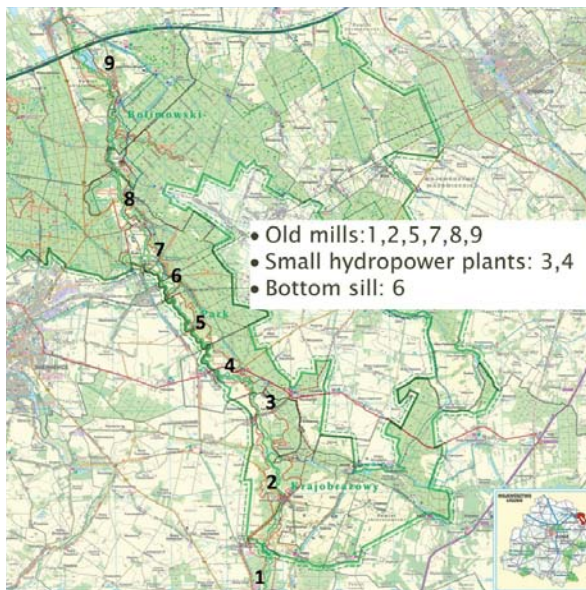
FIGURE 9. The location of damming structures along the Rawka river on the section of the Bolimowski Landscape Park

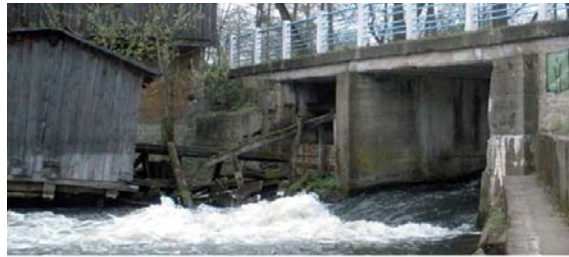
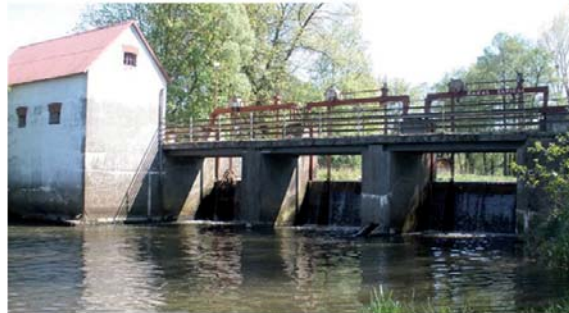
The old mill in Ruda village (km 30).

Small hydropower plant in Kamion village (km 37.8).

FIGURE 10. Views of some damming structures in the analyzed section of the Rawka river (photo Anna Opalińska)

The high natural-landscape value of the analyzed area results, among other things, from the long-term influence of damming structures which shape the habitat conditions both in the river bed and its valley. Most of the nine existing mill weirs lost their original damming functions and have been damaged or partially destroyed. Only two weir structures are in good technical condition since the old mills were rebuilt to small hydroelectric power plants. Of the remaining seven weirs, two require a complete reconstruction, while five – only renovation (Fig. 10).

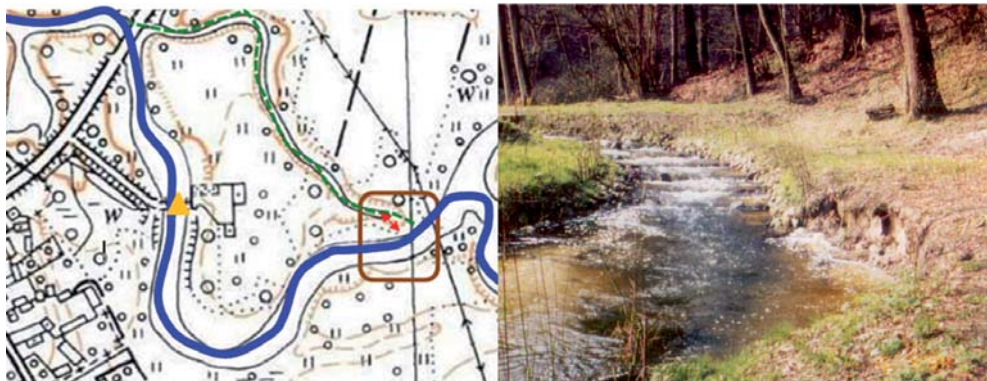
FIGURE 11. The conception of old mill bypass channels, adaptation (black dotted line) for fish migration: a – the area near Kamion hydropower plant (grey triangle), b – fish migration channel at the Seifert mill in Germany (WWF 2016)

- renovation and adaptation of existing two mill bypass channels to restore the conditions for fish migration (Fig. 11);
- construction of new fish migration channels in the area of three weirs, by merging the Rawka river channel with the estuary sections of the smaller streams – tributaries of the Rawka river (Fig. 12);

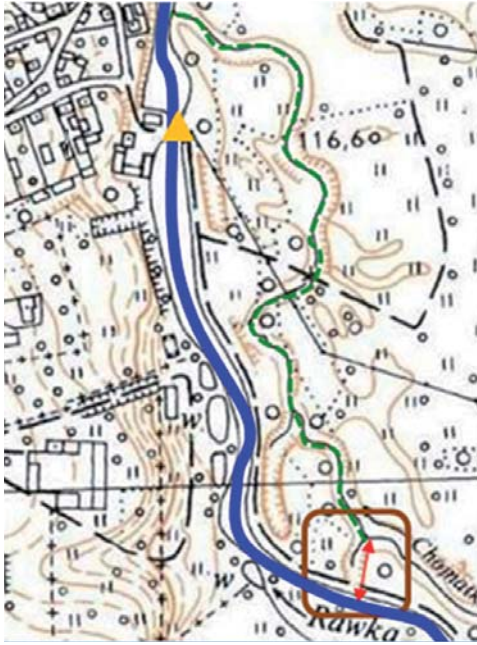
FIGURE 12. The adaptation of the estuary section of the Chojnatka riverbed for fish migration channel near hydropower plant in Suliszew (km 42.9)

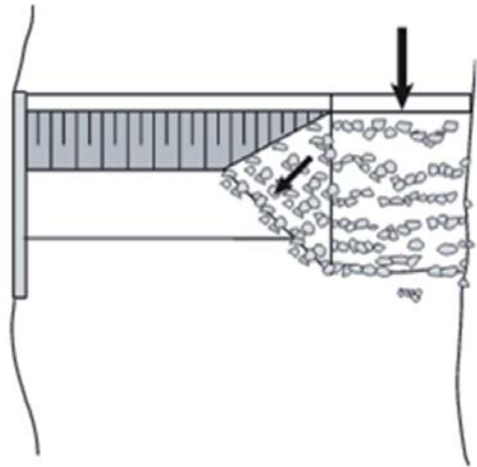
FIGURE 13. The scheme of small bottom sill 0.5–1.0 m height, combined with the stone-cascade fish pass (WWF 2016)

- construction of three damping steps of 0.5–1.0 m high with rocky fish-pass (Fig. 13).
