PESD, VOL. 12, no. 2, 2018

STUDIES AND RESEARCH ON NATURAL AND ANTHROPIC RISK THE MOLDOVA'S LOWER COURSE

Mihail Luca¹, Mihaela Avram², Alexandru-Lucian Luca³, Ștefania Chirica²

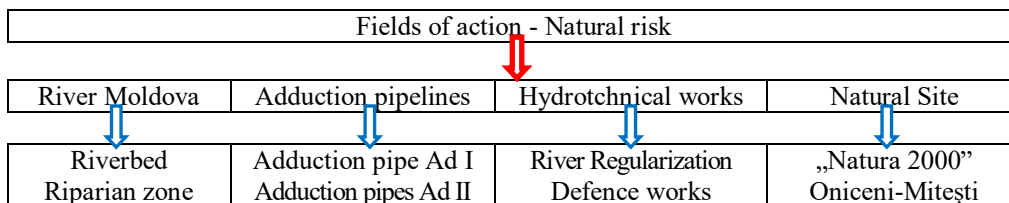
Fig.3. Fields of action of natural and anthropic risk in the study area

Natural risk factors and anthropogenic risk act in the area of study on the following natural, economic and social areas (Fig. 3):

- a - sector on the Moldova River (the minor bed and the riparian area) analyzed;
- b – Hydraulic installation undercrossing for the three adduction pipes;
- c - hydrotechnic constructions for riverbed regulation and shore defence works;
- d - the existing habitat in the riverbed and in the riparian area, belonging to the natural site "Natura 2000" Oniceni - Mitești.

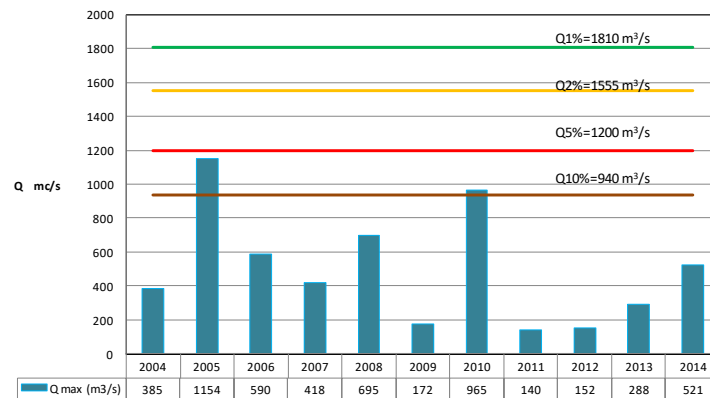
Fig. 5. The frequency of annual maximum flows during the 2004 - 2014 periods in the Soci section, Moldova River (Luca M., 2012)

The Moldova River crossed the Soci section in 2005 with a flood with $Q_{\max} = 1154$ m³/s; in 2010 there were two floods: first in summer with $Q_{\max} = 660$ m³/s; the second in autumn with $Q_{\max} = 965$ m³/s (Fig. 5). The flows and quotas on the Moldova River in the Soci section research area were calculated and are presented in Table 1 (Luca M., 2012). The maximum flow rate of 1402 m³/s was recorded in

1991 at the Tupilati hydrometric station. The historical minimum flow rate of $0.85 \text{ m}^3/\text{s}$ was recorded in 1987. The ratio between historical maximum and minimum historical flow is about 1649. High values of the coefficient of torrentiality are present also in the case of monthly average flows (about 170 ... 175) and even annual ones (about 5-6).

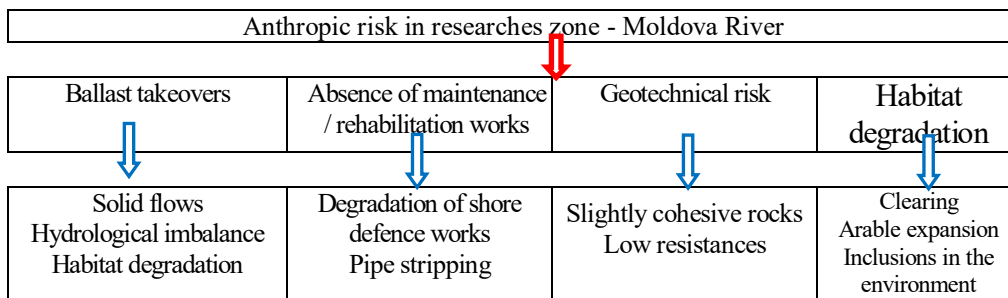
Fig. 6. Anthropic risk factors and mode of action on the Moldova River

The impact of anthropogenic risk factors has been felt in the last period of time. Studies and researches in the research area conducted of levels highlight the influence of anthropogenic risk factors on the current riverbed evolution (Fig. 6).

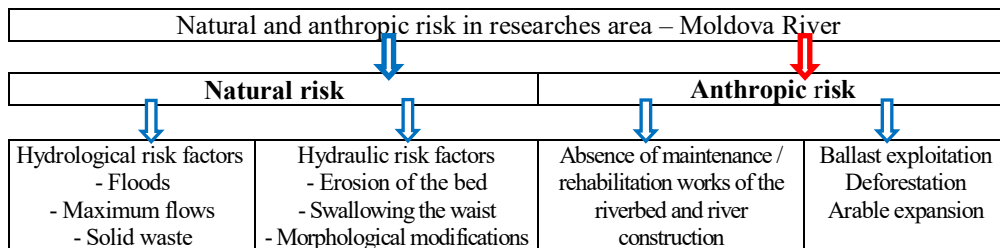
Fig. 10. Corroboration of natural and anthropogenic risk factors on the Moldova River - Soci area

The analysis carried out in the research area on the amplitude of the degradation of the undercrossing construction of the Moldova River by the Timisesti - Iasi adduction pipes, as well as the total degradation of the shore defence works, indicated the effect of the corroboration of the natural risk with the anthropic one (Fig. 10).

The accumulation of natural risk factors in the study area (floods, maximum flows, high frequency of peak flows, erosions, noncohesive rocks in the basin of the riverbed) with the anthropic ones (ballast exploitation, deforestation, absence of regulation and shore defence, the extension of the arable land) caused excessive degradation of the riverbed in the transverse and longitudinal plane (Fig. 11).

The excessive morphological modification of the riverbed caused the degradation of the stability and integrity of the adduction pipes Timisesti - Drinking for drinking water. Also, shore defence works and regularization works have been degraded differentially on both sides of the river. The shore defence on the right arm of the Moldova River was degraded by 90%, where the anthropic factor (ballast exploitation) occurred substantially.
